**Phase I Environmental Site Assessment  
Crowsnest Development Property  
Crowfoot Valley Road and Pradera Parkway  
Douglas County, Colorado**

ERO Resources Corporation  
1626 Cole Boulevard, Suite 100  
Lakewood, Colorado 80401  
(303) 830-1188  
ERO Project #25-293

January 15, 2026

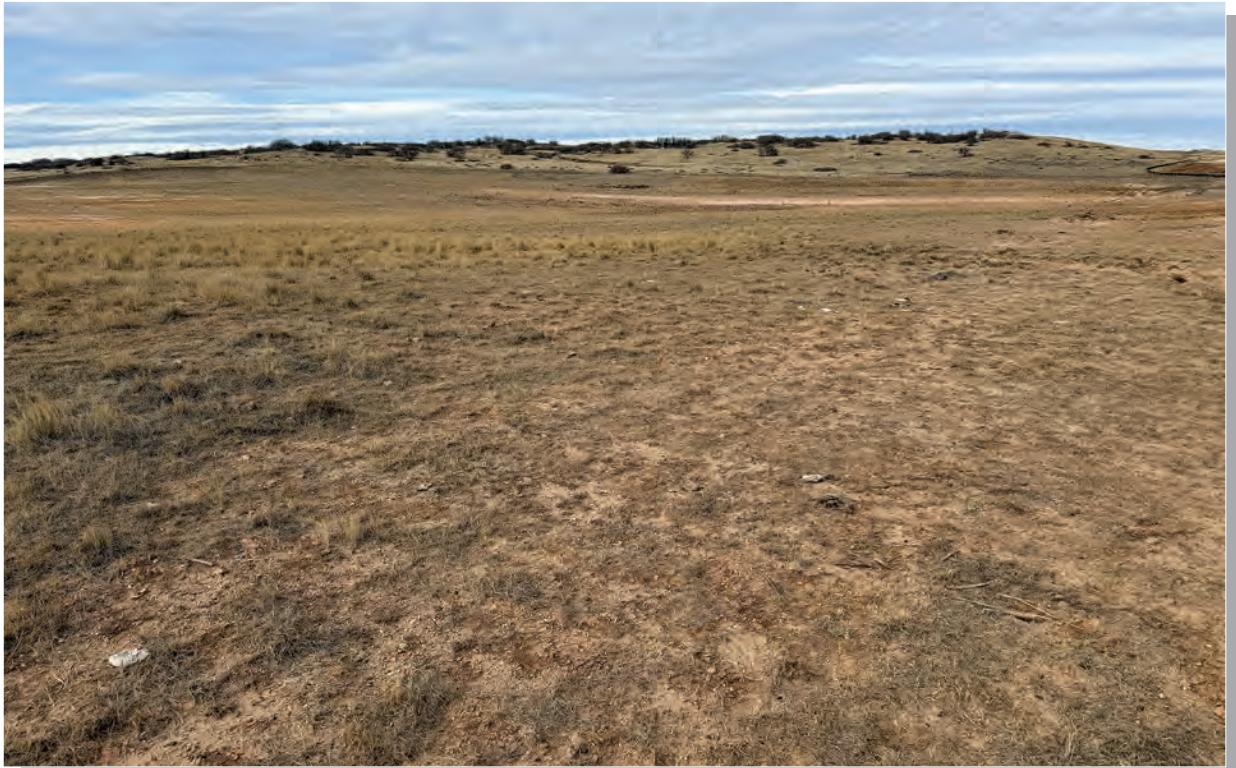
ERO reviewed records maintained by the Colorado Division of Reclamation, Mining, and Safety (CDRMS) for the subject property (CDRMS 2025). A former clay mine, the Stevens Clay Lease, was identified in the north-central portion of the subject property. According to the records, a permit to mine clay was issued to the Denver Brick Company in December 1997. The permitted area totaled 20.8 acres. Based on a review of historical aerial photographs, the mine operated until 2019, when the pit was filled with soil and overburden and the area was graded flat. No records were found for the former clay mine observed in aerial photographs in the central portion of the subject property.

**Photo 1** - The former Stevens clay mine in the northeast portion of the subject property.

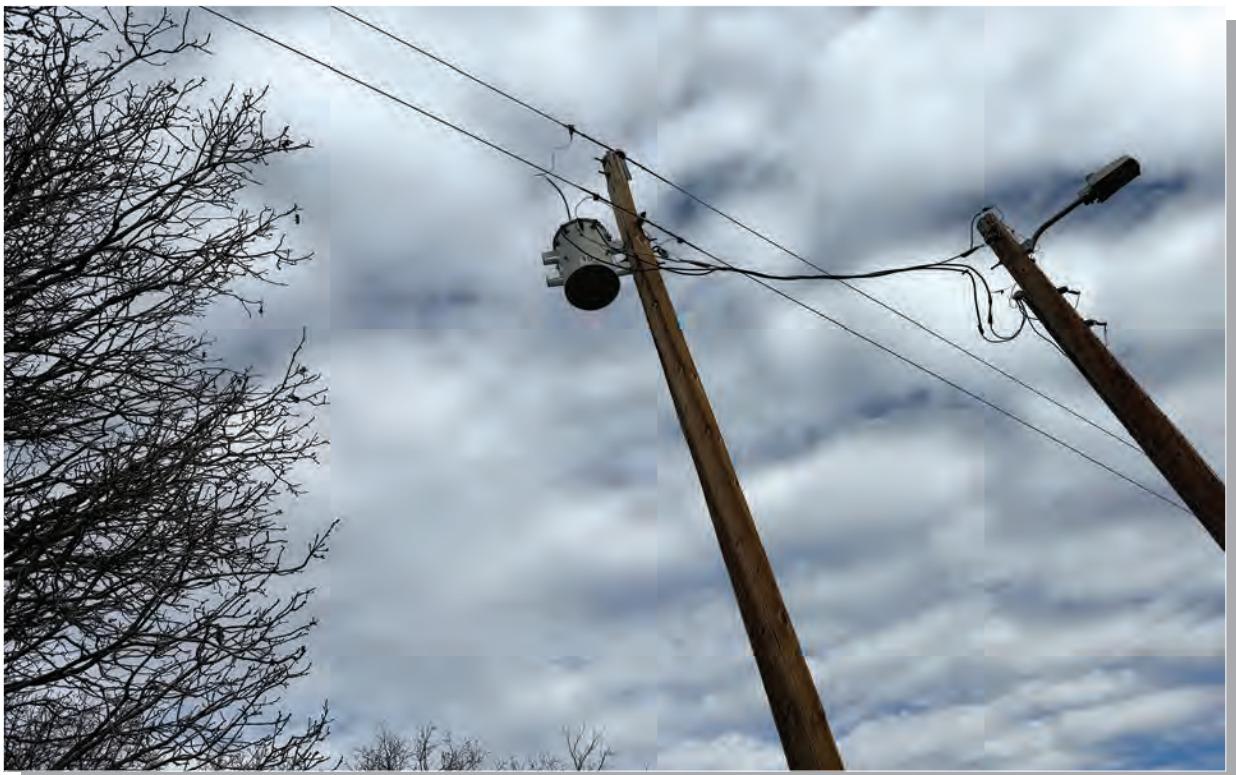
Pole-mounted electrical transformers were observed near the southwest and east-central residences and pad-mounted transformers were observed near the Crowfoot Castle parcel residence and storage building. The transformers were in good condition with no evidence of leaks on or around them.

**Photo 2** - Typical pole-mounted electrical transformer at the Doug Austin residence.

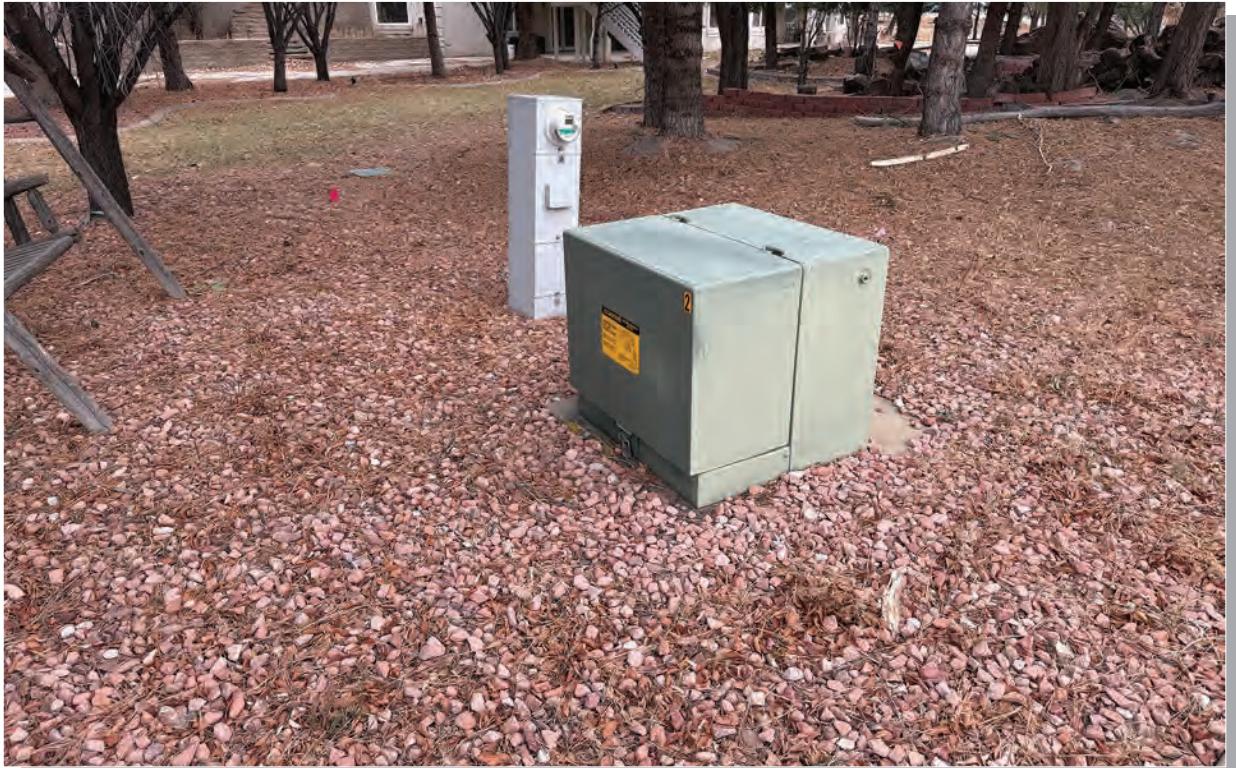
**Photo 3** - Pad-mounted electrical transformer at the Crowfoot Castle parcel residence.

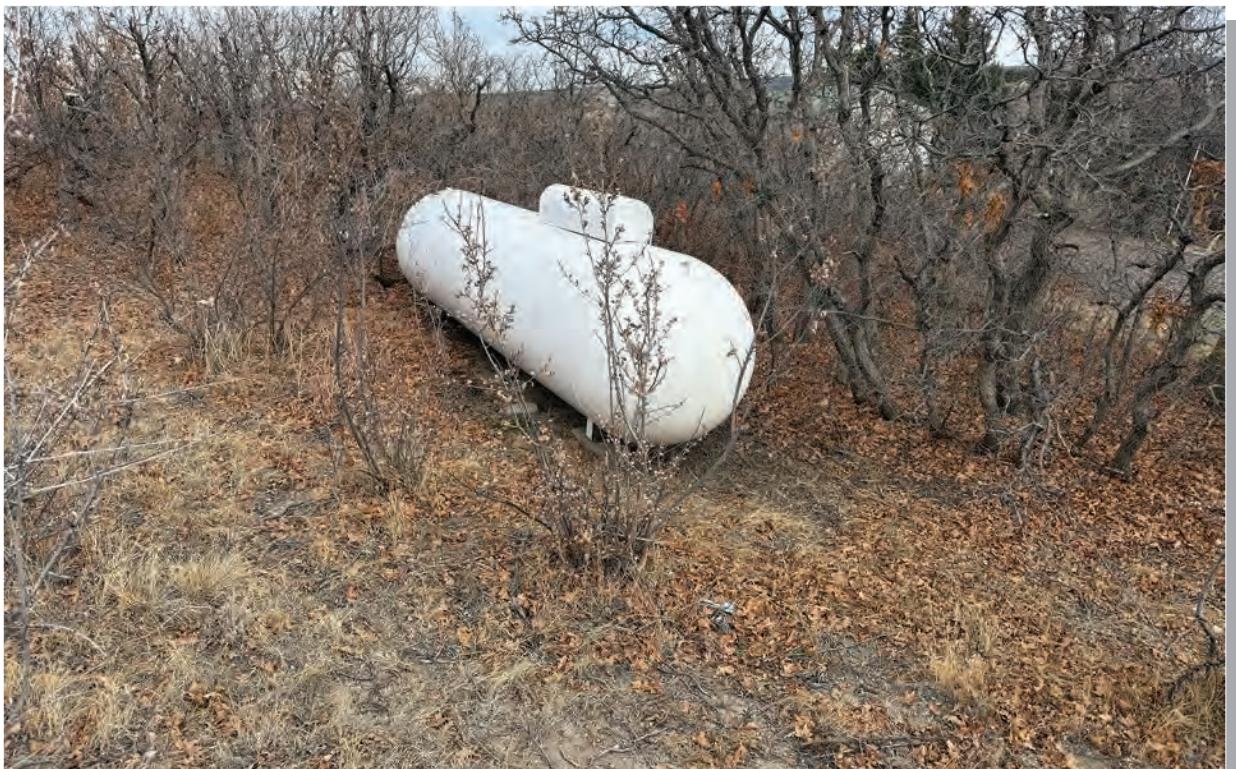
No vent pipes, fill ports, tank pits, or other indications of underground storage tanks were observed on the subject property. No aboveground petroleum storage tanks were observed on the subject property except for propane tanks at each of the occupied residences.

**Photo 4** - Typical propane tank at the Doug Austin residence.

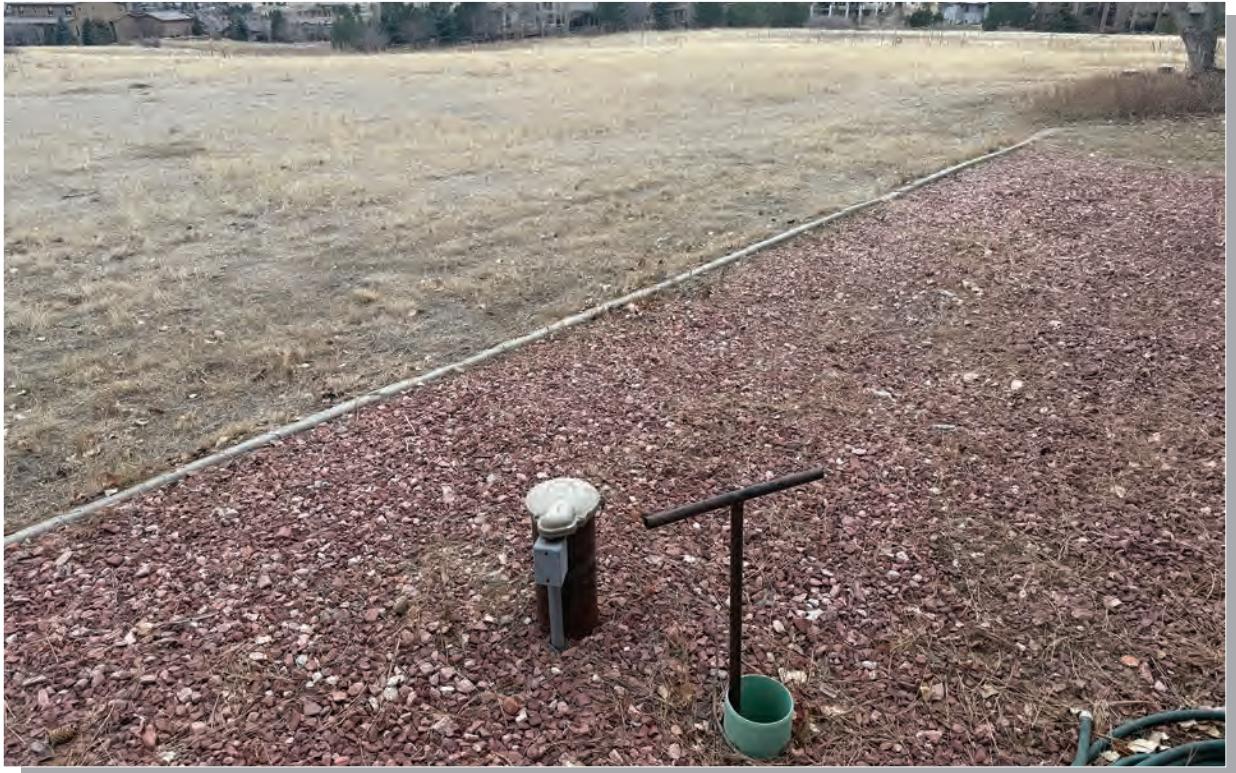
**Photo 5** - Typical domestic water well at the Crowfoot Castle residence.

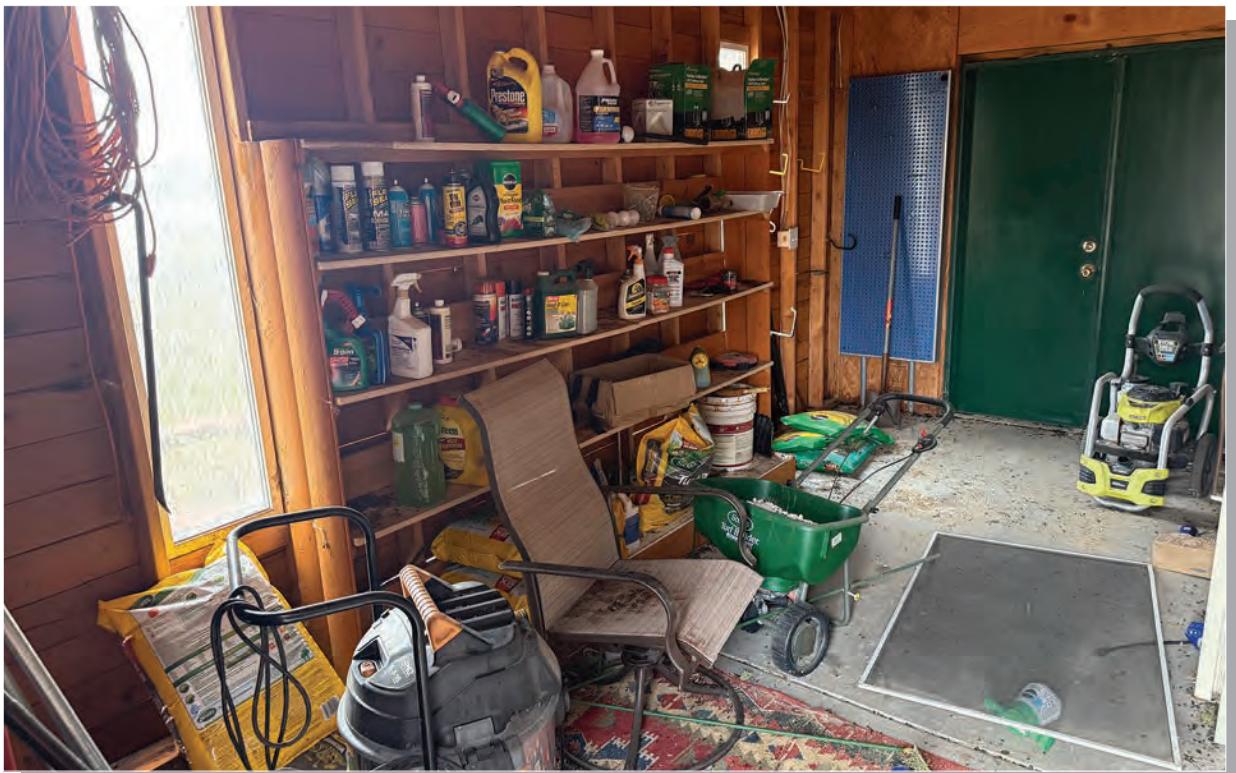
Several drums were observed on the subject property that were either empty or contained trash. Containers of vehicle, pool, home, and yard maintenance products were observed in a storage building at the Crowfoot Castle parcel residence. No indications of spills or leaks were observed around the drums and containers.

**Photo 6** - Containers of maintenance products at the Crowfoot Castle residence.

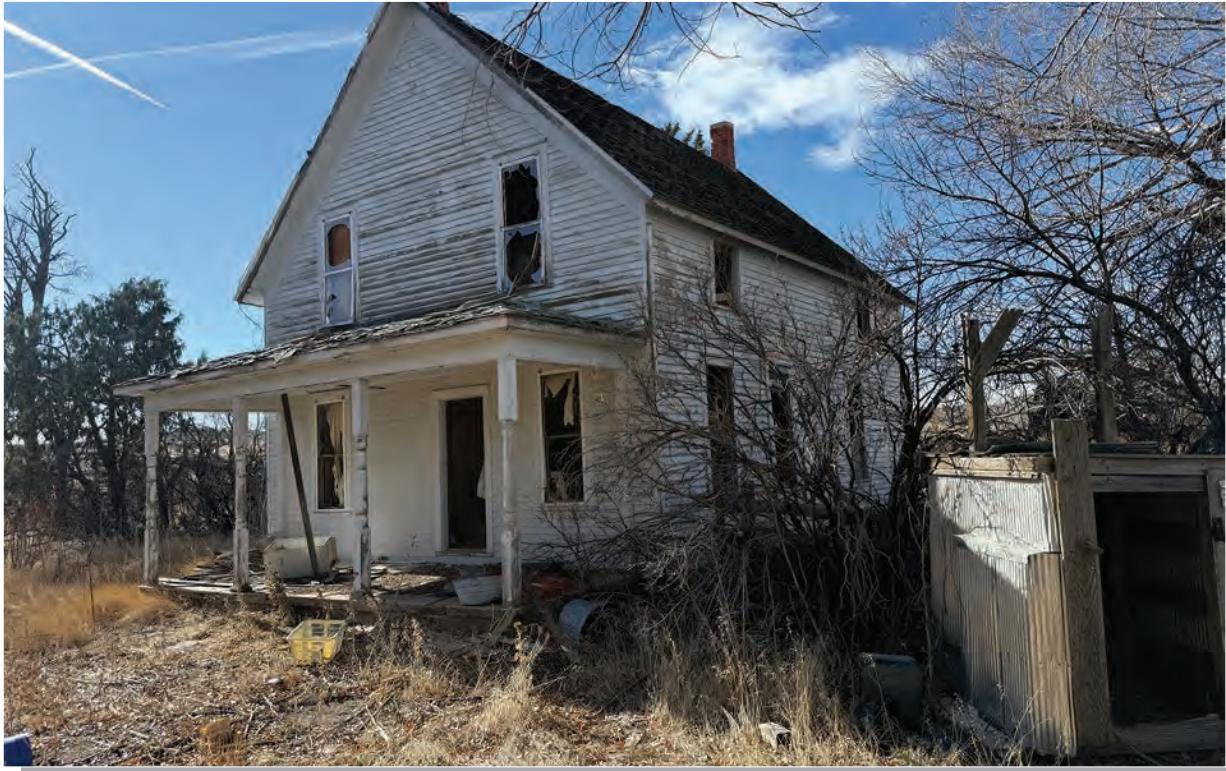
- Several of the structures in the northeast, abandoned farmstead area were significantly deteriorated such that roofing and building materials were observed to be scattered around the structures as well as within the collapsed buildings.

**Photo 7** - Abandoned residence in the northeast portion of the subject property.

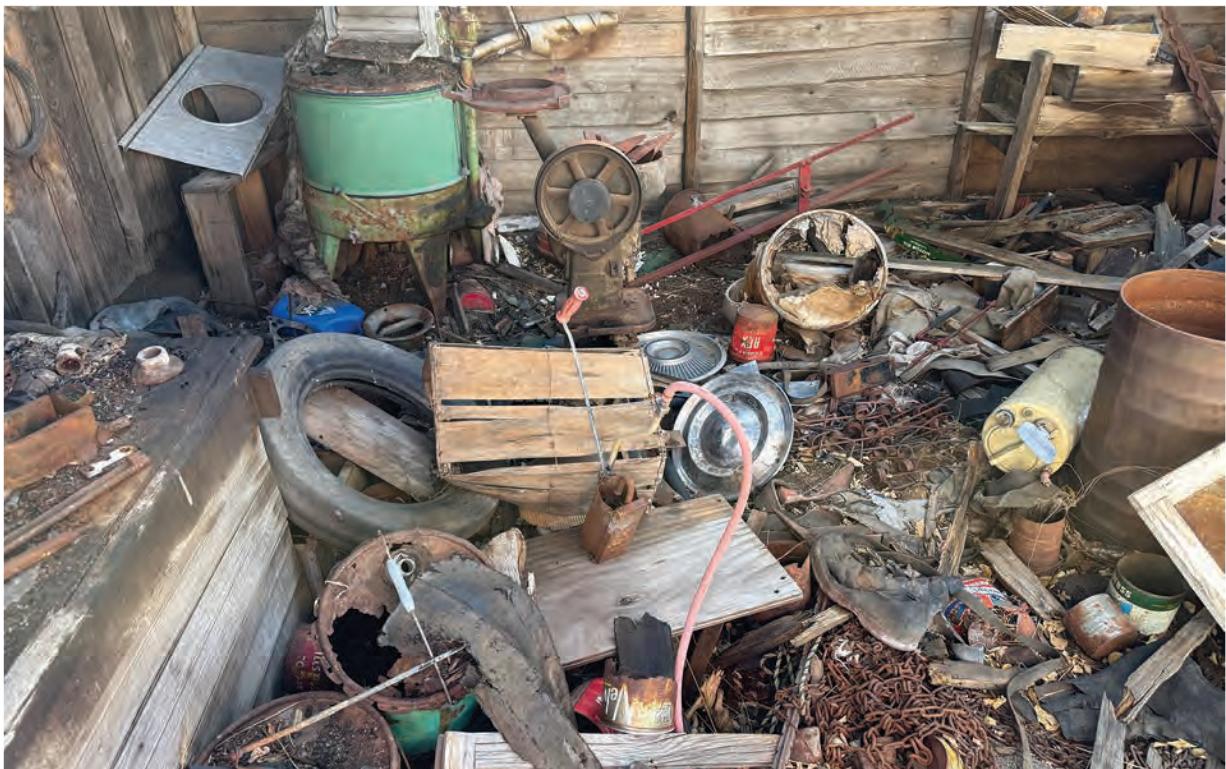
- Numerous containers of petroleum products and suspected hazardous substances were observed to be discarded within various structures on the abandoned farmstead parcel with indications of releases from several of the containers. The aggregate of the containers, lack of housekeeping, and indications of releases constitute a REC associated with the subject property;

Discarded and/or spilled containers of motor oil, petroleum products, and glass jars of unknown contents were observed in an outhouse and outbuilding within the area of the abandoned farmstead. Containers were observed to be in poor condition with spilled contents and no housekeeping.

**Photo 8** - Typical interior of the outbuildings at the abandoned farmstead in the northeast portion of the subject property.

- ERO was not able to interview any persons with an operational history of the abandoned farmstead parcel, which is a significant data gap because of the observed use or storage of petroleum products and hazardous substances within the structures. It is unknown if any persons remain that are familiar with the operational history of the parcel.
